NEWTOWN, CONNECTICUT

# HATTERTOWN POND DAM CT 00313

## PHASE I INSPECTION REPORT NATIONAL DAM INSPECTION PROGRAM

MAY 1981

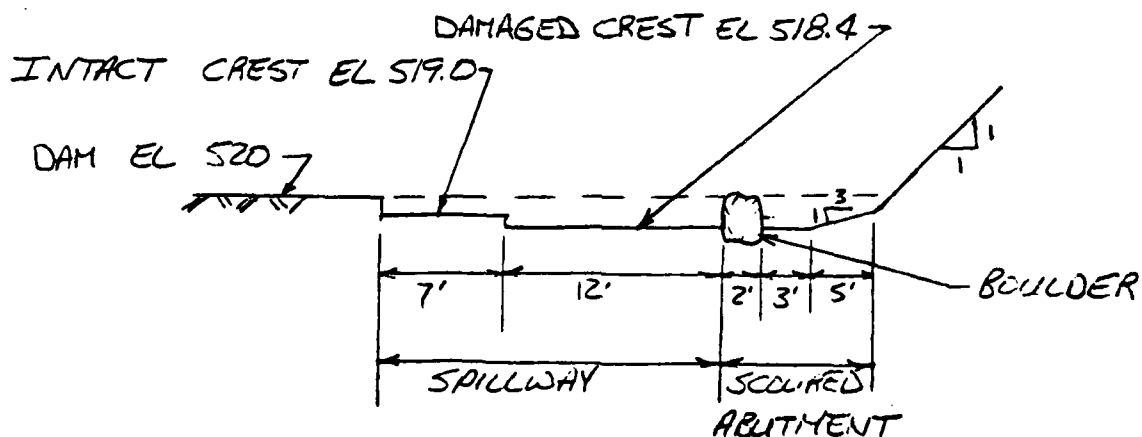
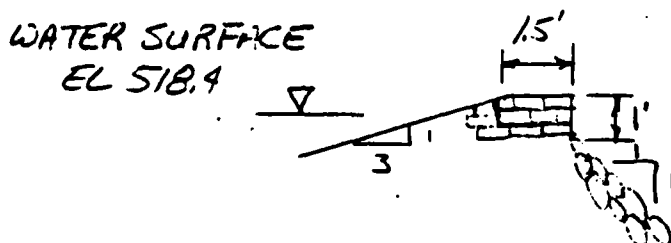
THE LEFT ABUTMENT, THAT HAS BEEN DAMAGED. THE INTACT PORTION OF THE SPILLWAY IS 1 FOOT BELOW THE TOP OF THE DAM (EL 520) AND THE CREST OF THE DAMAGED SPILLWAY SECTION IS 1.6 FEET BELOW THE TOP OF THE DAM. THE LEFT SPILLWAY ABUTMENT IS DEFINED BY A LARGE BOULDER WHICH SEPERATES THE SPILLWAY FROM A SCoured AREA AT THE DAM ABUTMENT. AN ELEVATION AND SECTION OF THE SPILLWAY ARE SHOWN BELOW.
